22. Site 22 at RM 436.4 LDB (Pool 18)

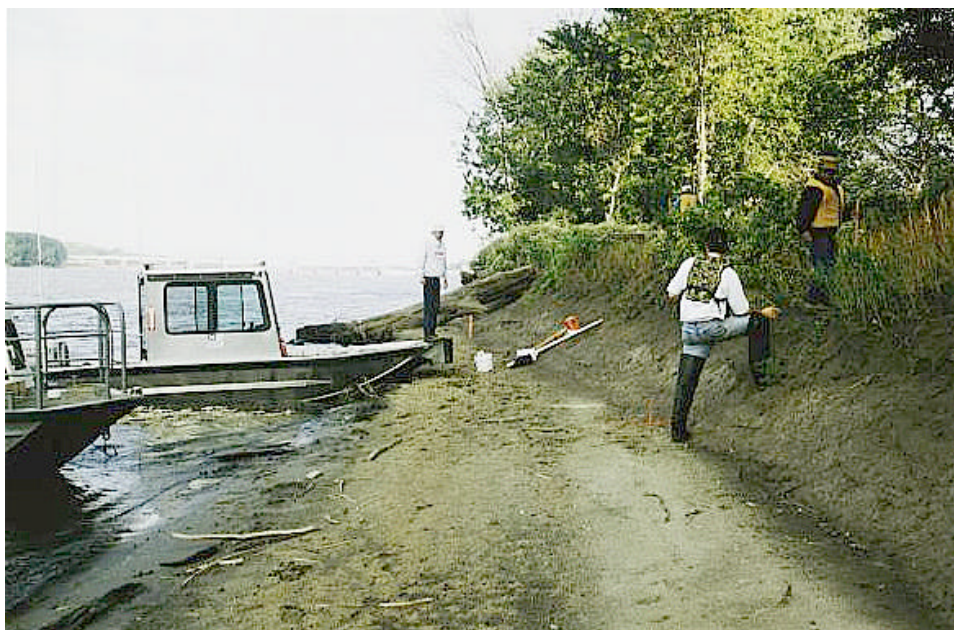
Photo 7-54 An upstream view of Site 22 midpoint

An upstream view of the midpoint section is shown in Photo 7-54. Five bank sections were taken at the erosion site: at the upstream limit; the upstream quarter point; the midpoint; the downstream quarter point; and the downstream point. The sections are depicted in figures 7-82 through 7-86. As can be seen in figure 7-84, the channel cross

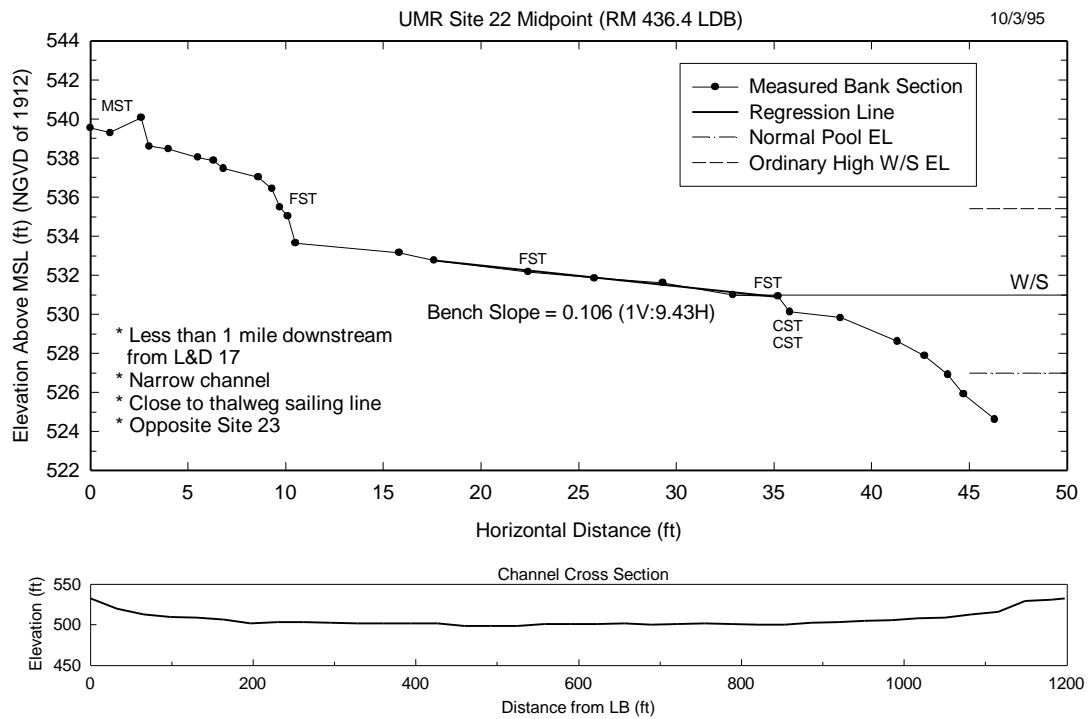
section is a typical parabolic shape common to straight channels. The bank soils consist of silt (FST-MST) with moderate piping features and subaqueous sediments are silt (MST-CST) and sand (VFS). Site 22 is very close to the thalweg sailing line. Steep subaqueous bank slopes observed along the bank downstream from the midpoint section indicate that this reach is subject to strong currents and vessel-induced prop-wash.

Figure 7-84 Bank section and channel cross section measured at Site 22 midpoint

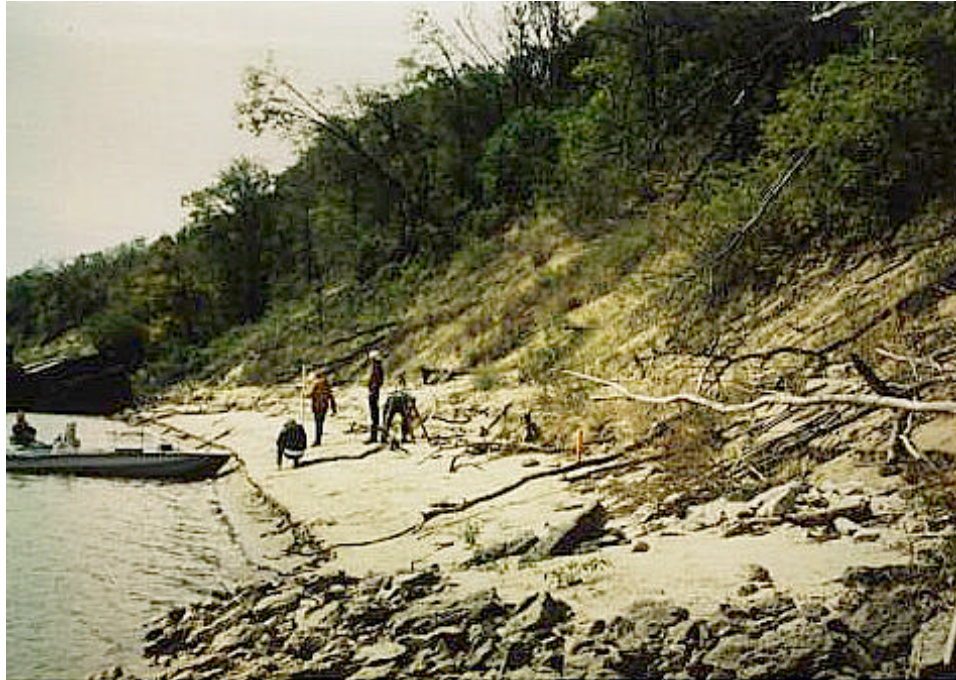
This right-bank site is located on the upper portion of Keg Island across the channel from Site 22 (see figure 7-81). A downstream view of the upstream site is shown in Photo 7-55. Two bank sections were taken at upstream and downstream points, and they are shown in figures 7-87 and 7-88. No midpoint section was established. The site is located far from the thalweg sailing line. As can be seen in figure 7-87 and Photo 7-55, stone slope-protection failure was observed at the upstream section. The bank soils consist of lensing silt (FST-CST) and some sand (FS) was found on the surface along the water's edge. Subaqueous sediments are silt (MST-CST) at the upstream section, and are silt (MST-CST) and sand (MS) at the downstream section.

Photo 7-55 A downstream view of Site 23 upstream point

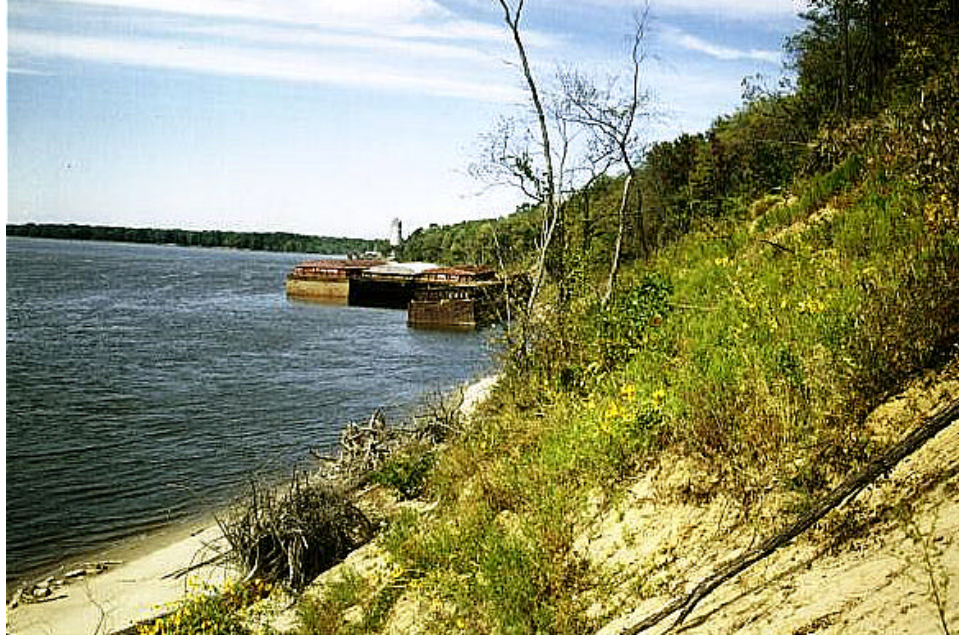
Photo 7-56 An upstream view of Site 24 midpoint

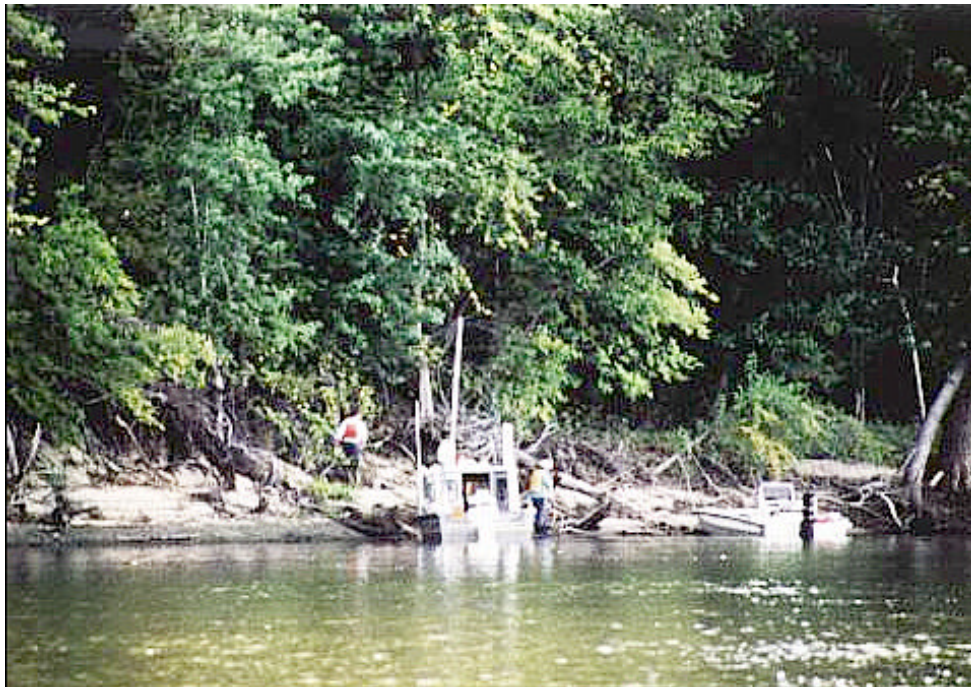
This right-bank island site is located opposite Site 24. An oblique view of this site is shown in Photo 7-57. One bank section taken is shown in figure 7-93. The bank soils are primarily silt (VFST-MST), and subaqueous soil is silt (MST) and sand (FS).

Photo 7-57 A side view of Site 25 midpoint

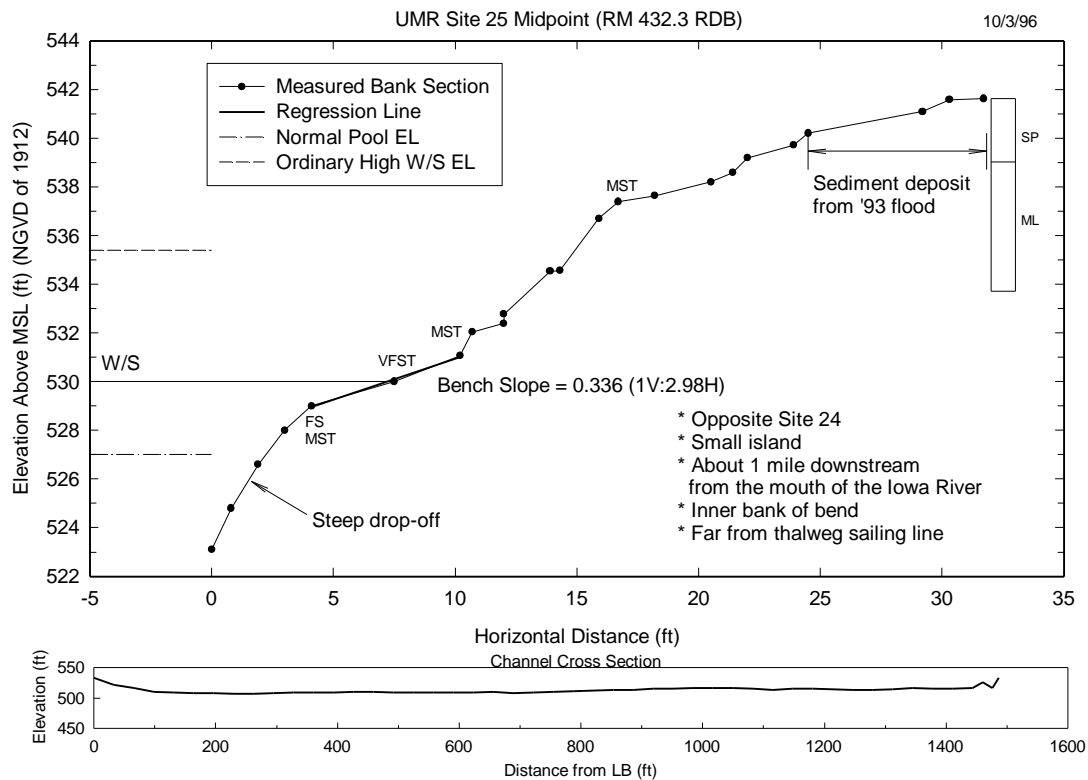
The island is covered by a recent sand deposit, about 3 ft deep, apparently from the Great Flood of '93. Causative factors for bank retreat at this site include flood-flow bank oversteepening and rapid recessional slumping and seepage, piping collapse, and wave and flow rework-transport of failed soils and recently deposited sediment cover within bench areas. The steep subaqueous drop-off is a strong indication of channel erosion at this site, as referenced in figure 7-93. Eroded bank type is a combination of Type C and Type D.

Figure 7-93 Bank section and channel cross section measured at Site 25 midpoint

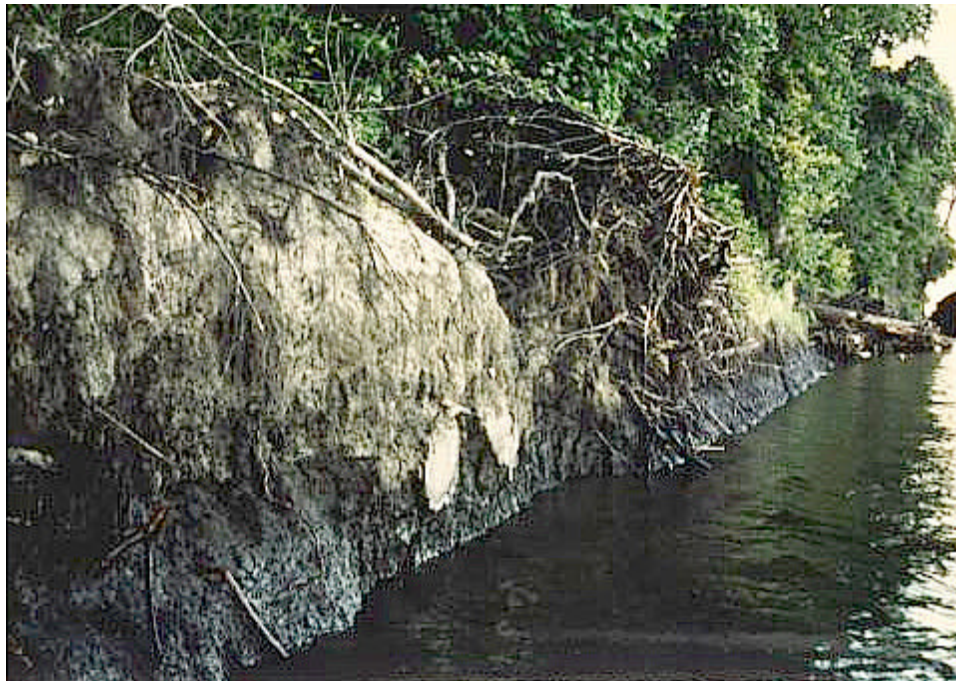
This right-bank site, shown in figure 7-94, is located on Camp Island along a straight channel reach. The site is about 9.5 miles upstream from Lock & Dam No. 18. Camp Island is one of numerous islands formed downstream from the confluence of the Mississippi River and the Iowa River. An upstream view of this site is shown in Photo 7-58. Three bank sections taken at this site are shown in figures 7-95 through 7-97. The bank soils are mainly silt (FST) and sand (MS-CS), and subaqueous bench soil is silt (VFST-MST). As can be seen in the river cross section (figure 7-96), the thalweg is developing along this island. Severe in-channel erosional bank oversteepening is indicated by the steep subaqueous bank slope.

Photo 7-58 An upstream view of Site 26 midpoint

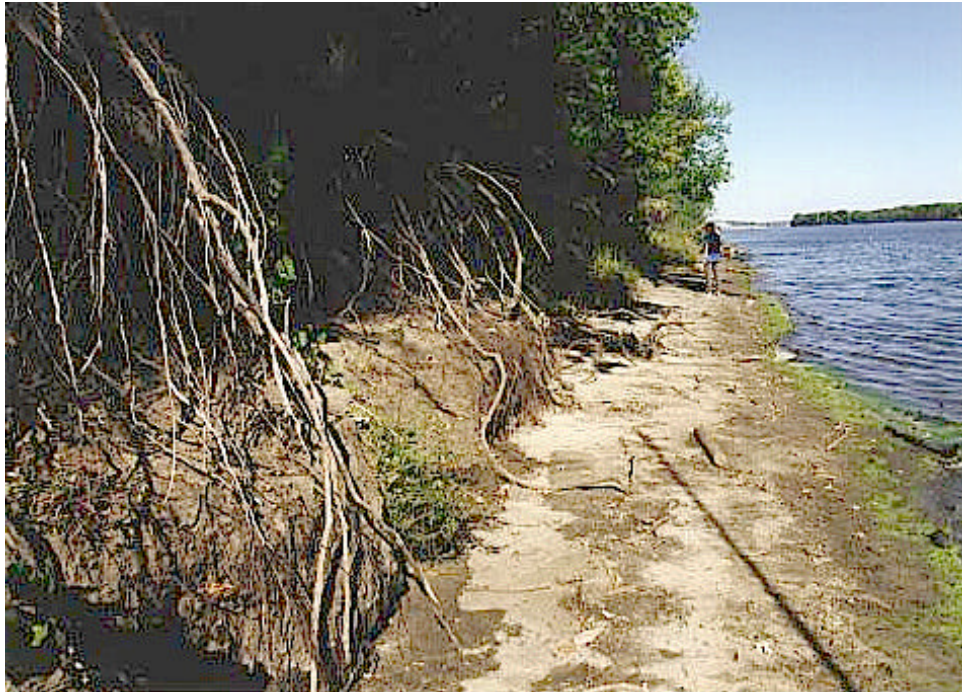
Photo 7-59 An upstream view of Site 27 midpoint

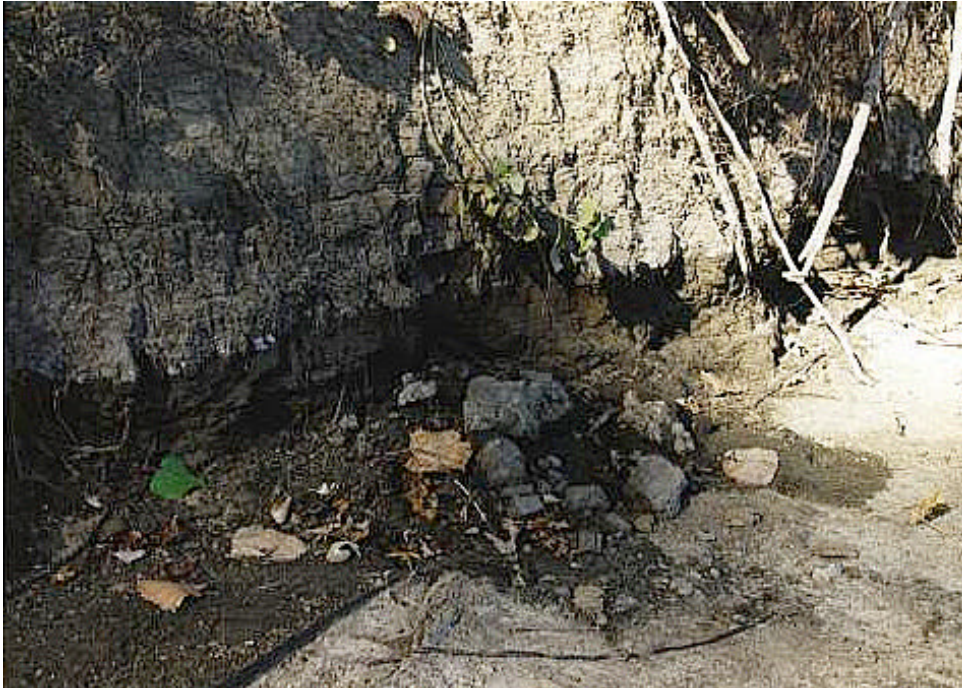
river stage levels were lower compared to periods earlier in the year. Soil blocks were observed to be calving and slumping into the river's channel margin. The instability of the banks, indicated by the slumping soil blocks, may be caused by several factors,

Photo 7-60 A close-up view of scarp at Site 27 midpoint

including (1) weakening of the soil body from vertical fracturing; (2) a lower river stage which caused a steepening of the bank slope; (3) wave actions undermining fine sands along the bank interbedded by silt/fine sand alluvial sequence; (4) head differences between the water table and river level, causing groundwater flow along weaker fine sand seams; and finally, (5) less hydraulic bank support during low water dry periods. Moist conditions and higher river stages, higher water table elevations, and improved soil moisture would tend to provide hydraulic support of the soil body.

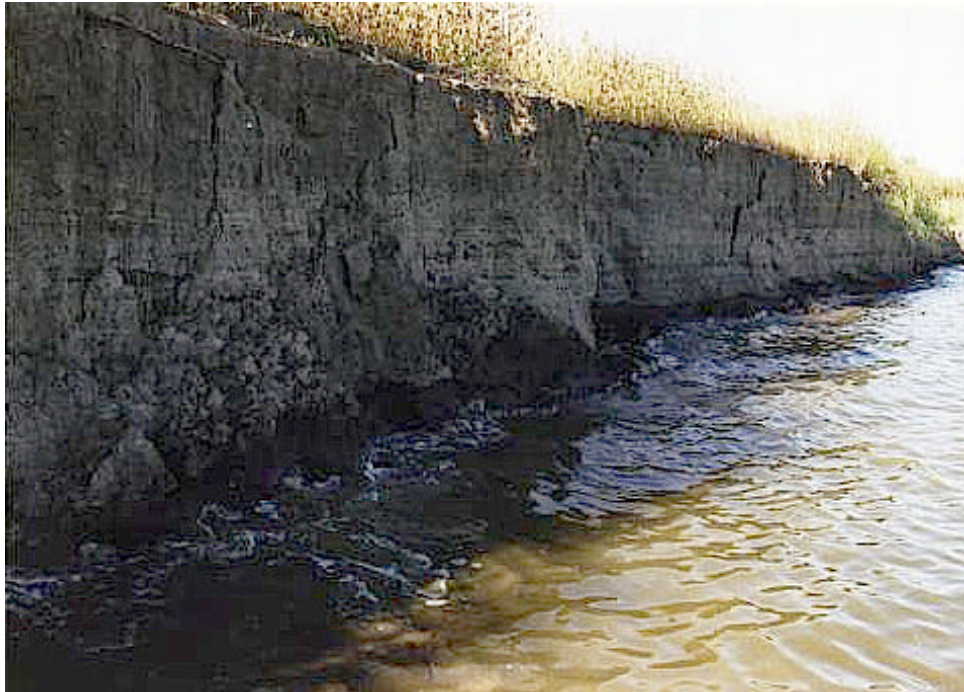
Photo 7-61 An upstream view of Site 28 midpoint

shows an upstream view of the site and Photo 7-62 is a close-up of the scarp. Photo 7-63 shows extensive vertical cracks associated with block failures along the bank face, and Photo 7-64 shows piping features and vertical cracks. Shown in figure 7-100 is the bank section obtained at this erosion site. The river cross section shown in figure 7-100 has a typical shape for a crossover reach characterized by a nearly constant depth across the width. The scarp, about 7 ft high, is nearly vertical, and the bank soils are predominantly MST.

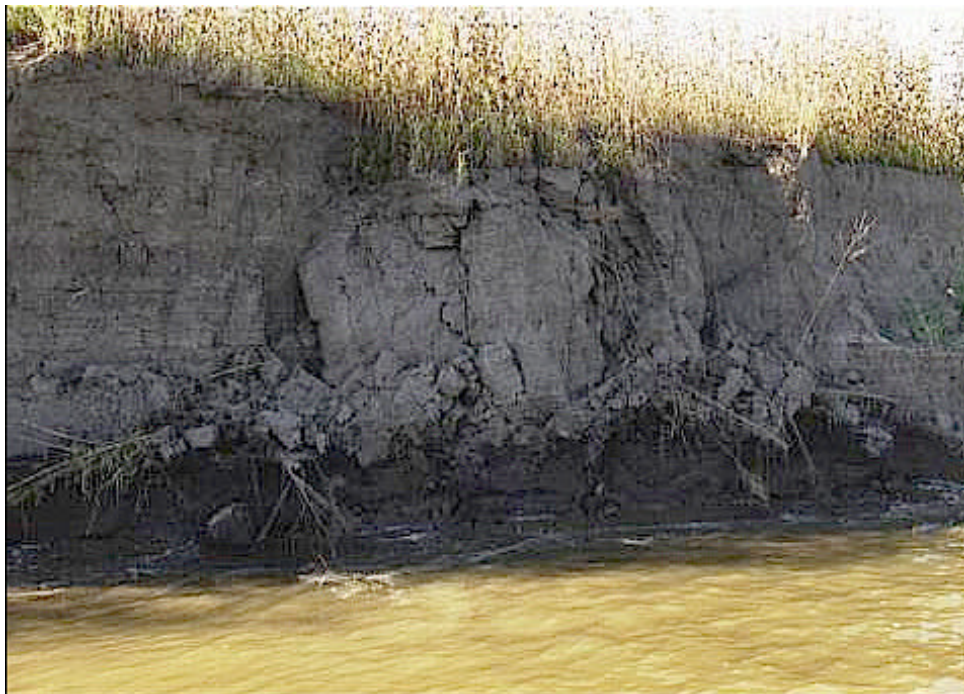
Photo 7-62 A close-up view of scarp at Site 28 midpoint

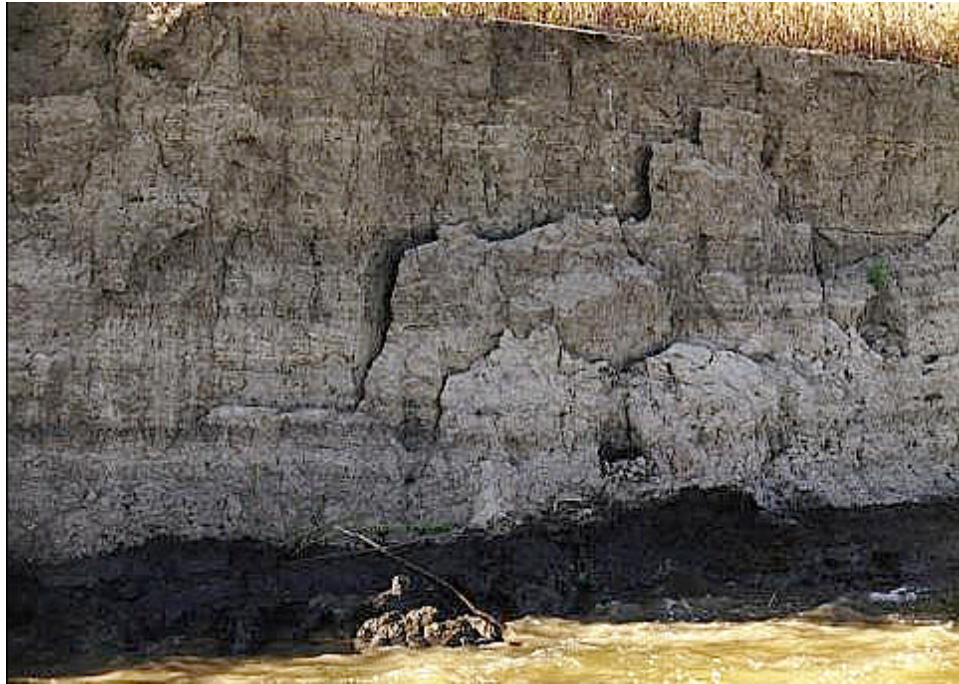
Photo 7-63 Vertical cracks and massive block failures at Site 28 midpoint

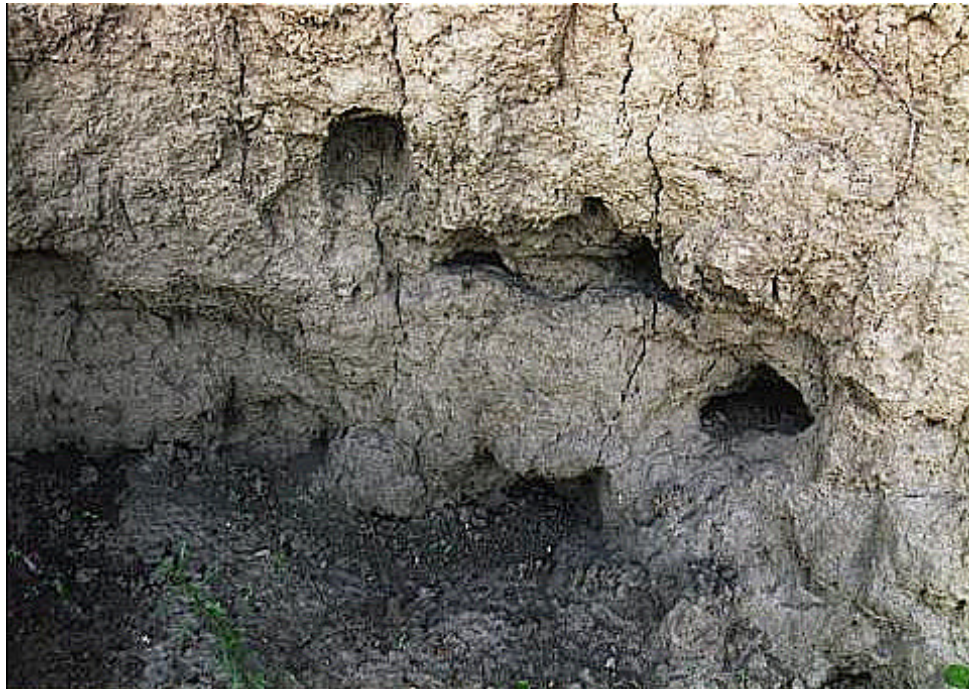
Photo 7-64 Piping features and vertical cracks seen at Site 28 midpoint

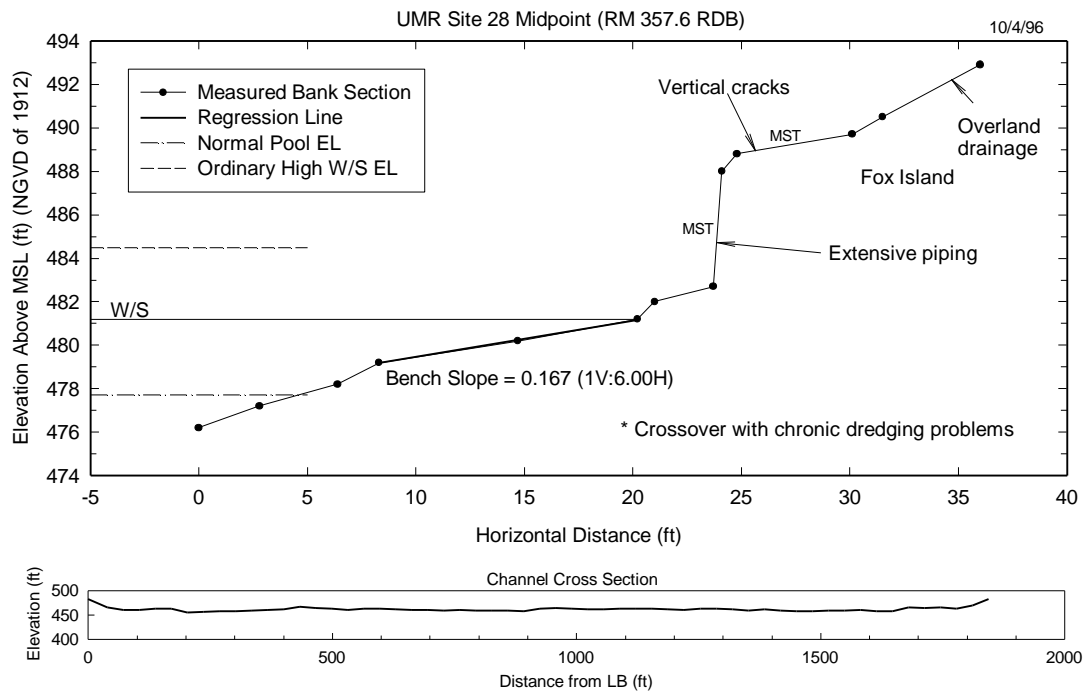
Figure 7-100 Bank section and channel cross section measured at Site 28 midpoint
